# FIELD INSPECTION REPORT

Project Name:	Mountain Valley Pipeline	Inspector:	Matthew Grant
Inspection Date:	Wednesday, September 29, 2021	Project Contact:	Brian Clauto
Spread H: Montgomery	AR 270, 270.01 ATWS 1163, 1162 St12072-12106+77	Weather:	Dry

# FIELD INSPECTION PHOTO LOG

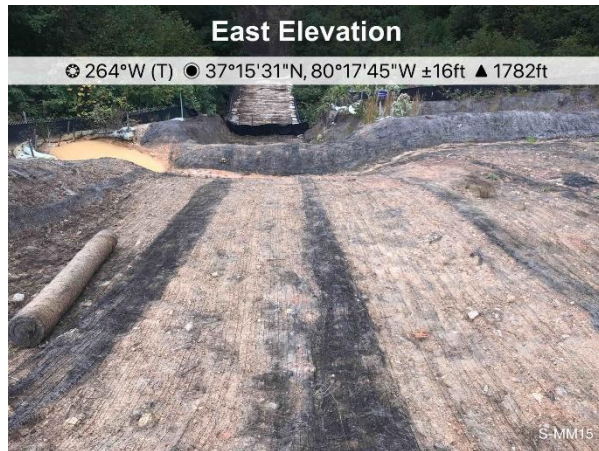
- Figure 1: Matting has deteriorated on slopes leading to S-MM15.

**Recommended Corrective Action:** Maintain and install all controls per the approved PSS&S.

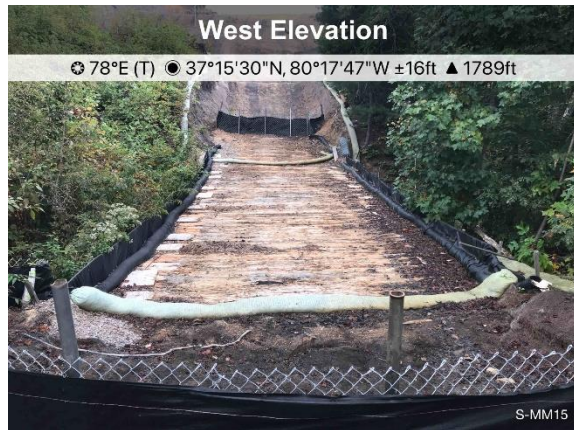
- Figure 2: Designated crossing S-MM15, ECD's are in place for active construction. Matting on both sides of crossing has deteriorated.

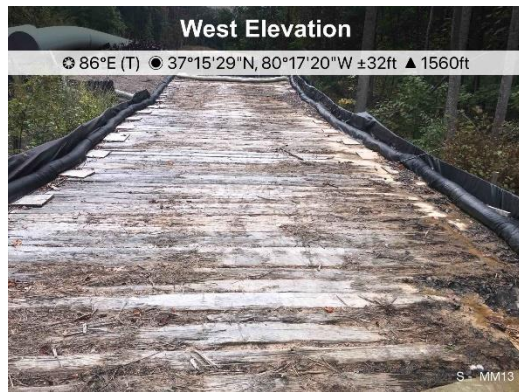
- Figure 3: Designated crossing S-, ECD's are in place for active construction.

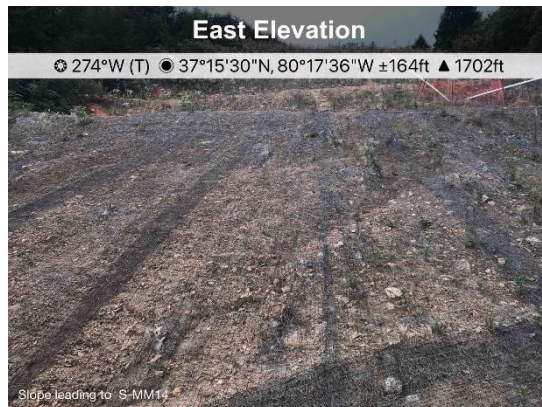
- Figure 4: Matted slope on coming in side leading to designated crossing S-MM14 has deteriorated.
